MOISTURE & MOLD

ASSESSMENT

SAMPLE REPORT

A mold assessment and testing was performed on March 20, 2018 by Caroline Hovey, Principal Environmental Specialist, of Hovey Environmental LLC. The subject property is located at XXXXX in San Diego, California.

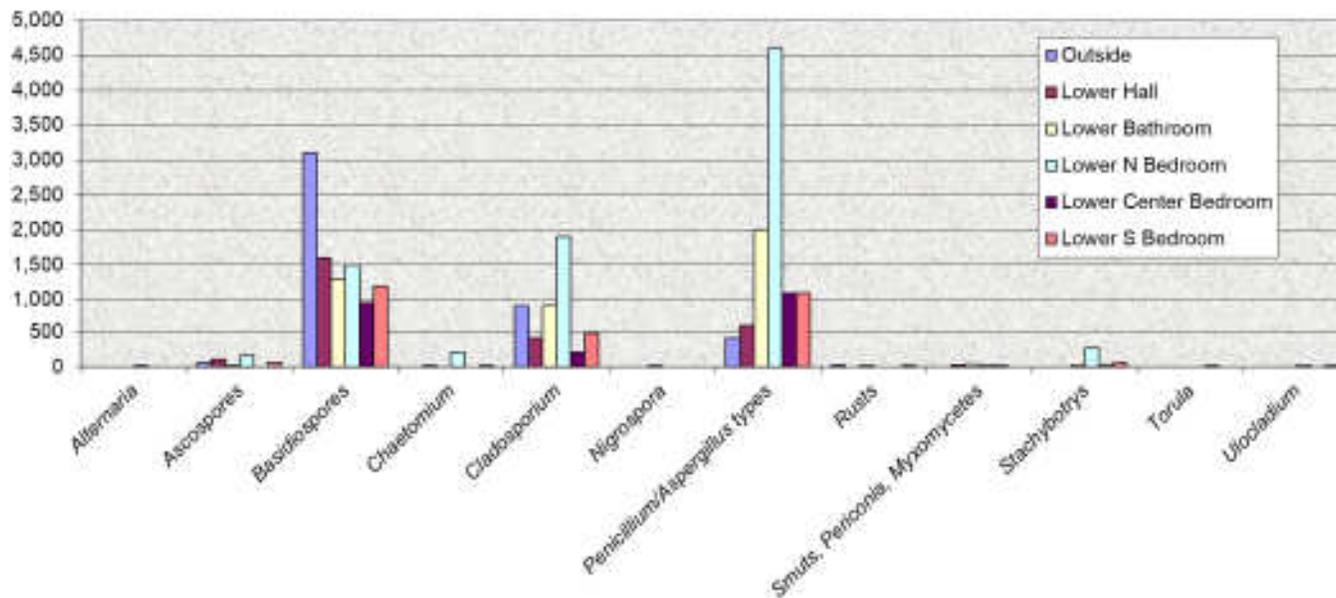
Figure 1. Concentration of mold types in air samples.

Results of samples taken at the subject property are provided in Appendix A. Air samples were taken to establish the concentration of spores in ambient air. The total concentration of mold spores per cubic meter of air is given in Table 2. The concentration of individual mold types (spores/m³) from each sample is given in Figure 1. Results from the outdoor sample are shown by the dark blue bars. This data can be used as a basis for comparison for indoor samples. Under normal conditions, the concentration of spores and types present should be consistent with that captured outside.

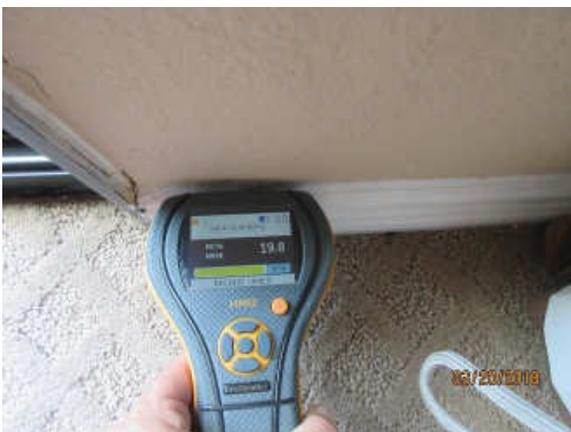
Moderate moisture readings (approximately 20%) were detected at the base of the west wall to the right of the slider in the family room. Mold growth was noted along the bottom edge of the baseboard as well as on the sub-floor below the carpet.

Elevated moisture readings on wall next to slider

Due to the presence of abnormal mold conditions and elevated moisture levels, remediation (treatment) is recommended in the family room. The area should be contained prior to removal of affected materials. The carpet, pad, and tack strips should be removed and discarded. Baseboards, drywall, and insulation should be removed from the lower two feet (minimum) of the walls to the left and right of the slider. All exposed surfaces should be treated as outlined on page 12. Additional removal and/or treatment may be necessary and can be determined as part of the remediation process. It is important that all moisture sources be evaluated and corrected. A window and/or deck specialist should be retained to determine how moisture is penetrating around the slider and determine appropriate corrective action needed.

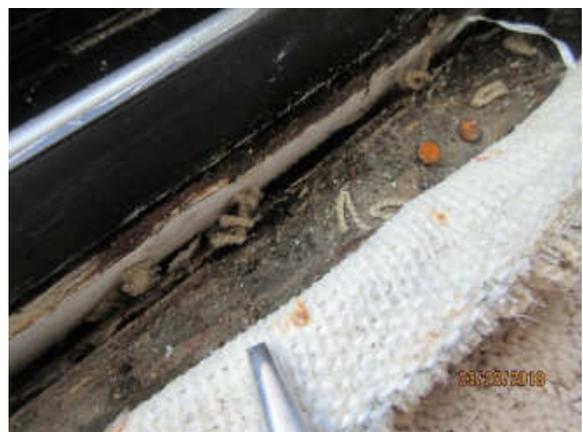
Results of the swab sample collected from the family room showed the presence of *Stachybotrys* mold growth. This is an indicator organism whose presence is indicative of an abnormal mold condition due to prolonged or repetitive moisture exposure.

Mold growth on tack strip and subfloor in front of slider

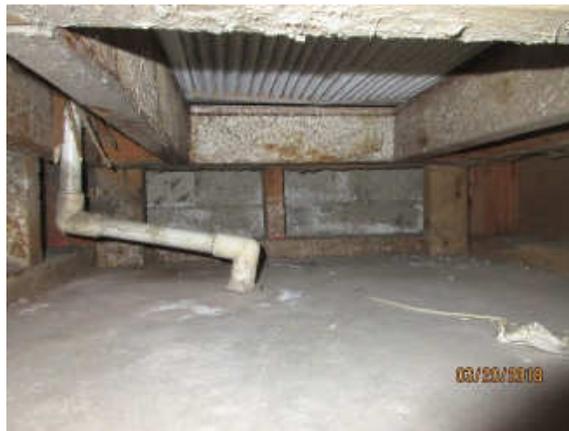
The east wall in the lower hall is built below grade. Most of this wall was inaccessible due to personal items in the closet and the position of the washer and dryer. The register was removed from below the HVAC closet and efflorescence was noted on the block retaining wall. This indicates there may be some moisture intrusion occurring through the retaining wall. The HVAC inspector indicated there is mold growth on the coils in the HVAC.

Efflorescence on retaining wall below HVAC

Additional investigation is recommended to determine the extent of moisture intrusion through the retaining wall at the east side of the home. Once the personal items are removed, exploratory cuts should be made in the east wall to inspect the wall cavities. If mold growth is present on the backside of the drywall the impacted area should be removed along with an additional two feet in each direction. The HVAC inspector should be consulted to determine if the mold growth present can be cleaned or if the unit must be replaced. In either case, duct cleaning is recommended to remove any potential cross-contamination.

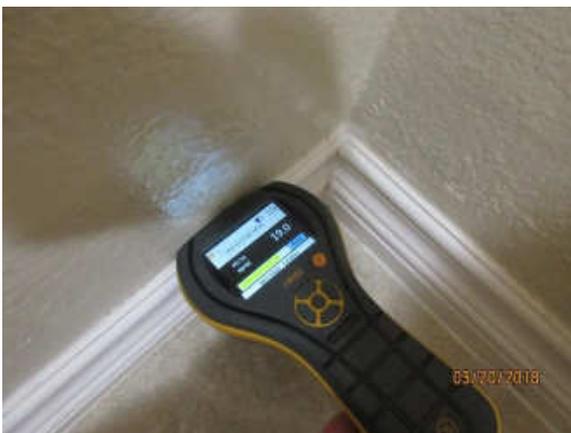
Moderate moisture readings (approximately 19% - 20%) were detected at the base of the east and south walls at the SE corner of the lower bathroom. Both of these walls are below grade. It is unclear if the elevated moisture readings in this area are due to moisture intrusion through the retaining wall or from a leak in the nearby toilet.

Elevated moisture readings on east wall

Due to the presence of abnormal mold conditions and elevated moisture levels, remediation (treatment) is recommended in the lower bathroom. The area should be contained prior to removal of affected materials. The toilet should be removed. Baseboards, drywall, and insulation should be removed from the lower two feet (minimum) of the east and south walls. All exposed surfaces should be treated as outlined on page 12. Additional removal and/or treatment may be necessary and can be determined as part of the remediation process. It is important that all moisture sources be evaluated and corrected.

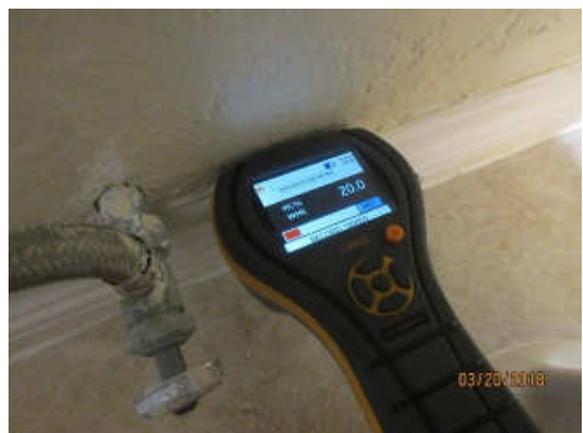
Elevated moisture readings on south wall

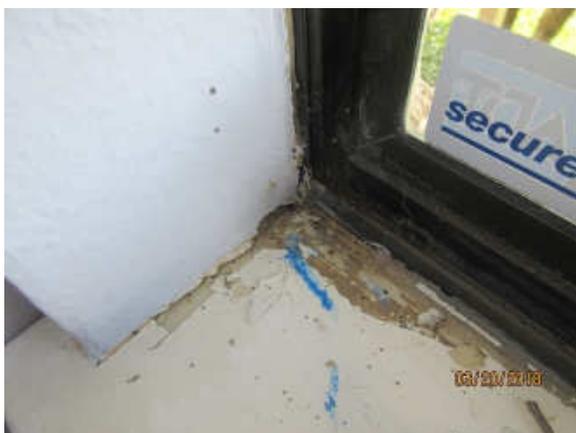
Several areas of concern were noted in the lower north bedroom. Elevated moisture readings (19% - 26%) were detected on the windowsill and base of the wall below the window. The baseboard was swollen, indicating prolonged moisture exposure. The wooden windowsill was rotted. Rot was also noted around the exterior of the patio door. At the top of the west wall, drip marks were noted below the drywall nails. This is likely due to moisture intrusion below the slider in the family room directly above. Near the center of the room, a small area of staining and elevated moisture (18%) was noted on the ceiling.

Moisture damage on windowsill

Due to the presence of abnormal mold conditions and elevated moisture levels, remediation (treatment) is recommended in the north bedroom. The area should be contained prior to removal of affected materials. The carpet, pad, and tack strips should be removed. Baseboards, drywall, and insulation should be removed from the lower two feet (minimum) of the west wall below the window, south and west walls next to the patio door, top of the west wall, ceiling within two feet (minimum) of the west wall, and center of the ceiling in the area of staining. All exposed surfaces should be treated as outlined on page 12. Additional removal and/or treatment may be necessary and can be determined as part of the remediation process. It is important that all moisture sources be evaluated and corrected.

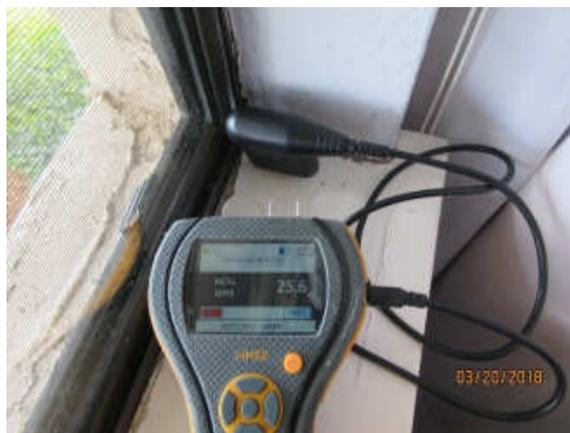
Elevated moisture readings on windowsill

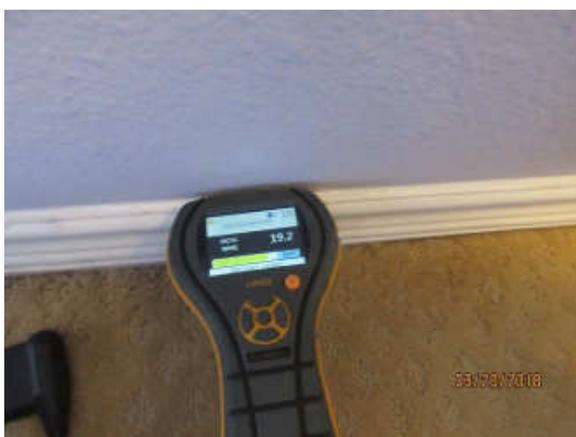
Elevated moisture readings at base of wall below window

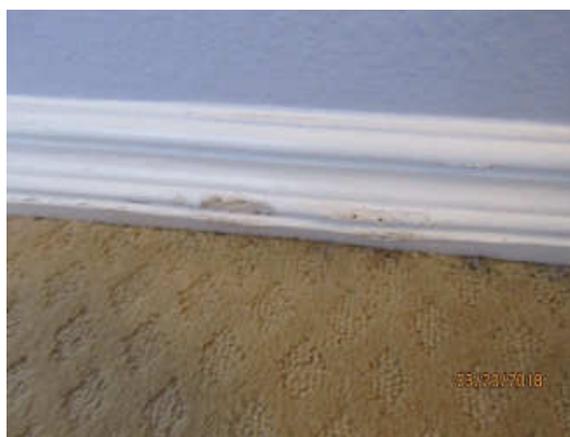
Swollen baseboard below window

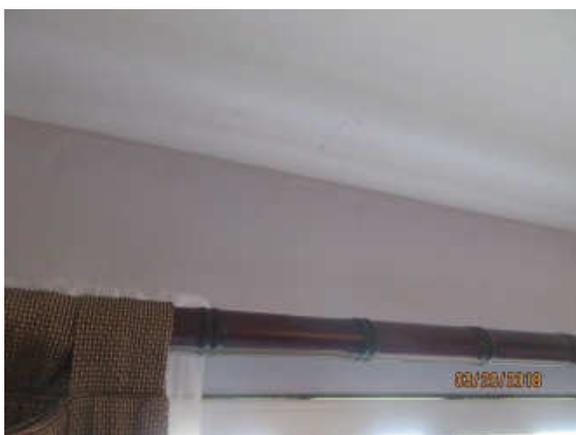
Drip marks at top of west wall

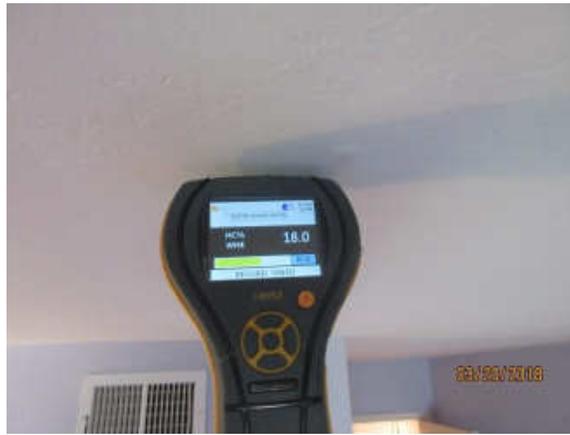
Elevated moisture readings on ceiling near center of room

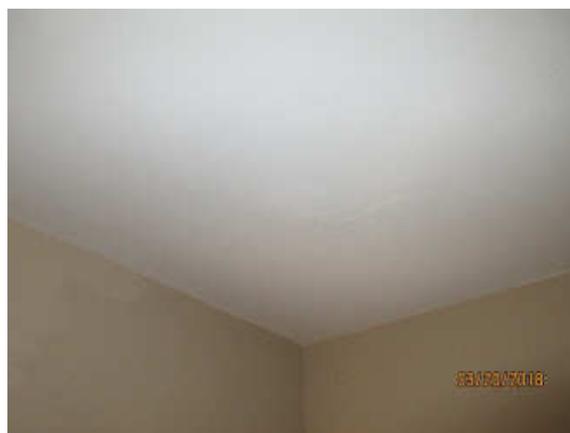
Bubbling paint was noted on the ceiling at the SW corner of the lower center bedroom. Moisture readings were low (<15%) at the time of the evaluation; however, the drywall was soft indicating prolonged moisture exposure. The baseboard at the base of the wall next to the slider was separating from the wall, which may be an indication of previous moisture exposure.

Bubbled paint at SW corner of room

Additional investigation is needed to determine if there is a localized source of mold growth in the lower center bedroom. Exploratory cuts are recommended in the ceiling at the SW corner of the room as well as the base of the wall next to the slider. If mold growth is present within the ceiling or wall cavity, the impacted drywall should be removed along with an additional two feet in each direction and the exposed surfaces treated as outlined on page 12.
